Summer 2011 - Concrete and stone cap installed along pond bank by previous owner to prevent erosion

Fall 2019 – Shoreline restoration project started. Removing concrete cap debris.

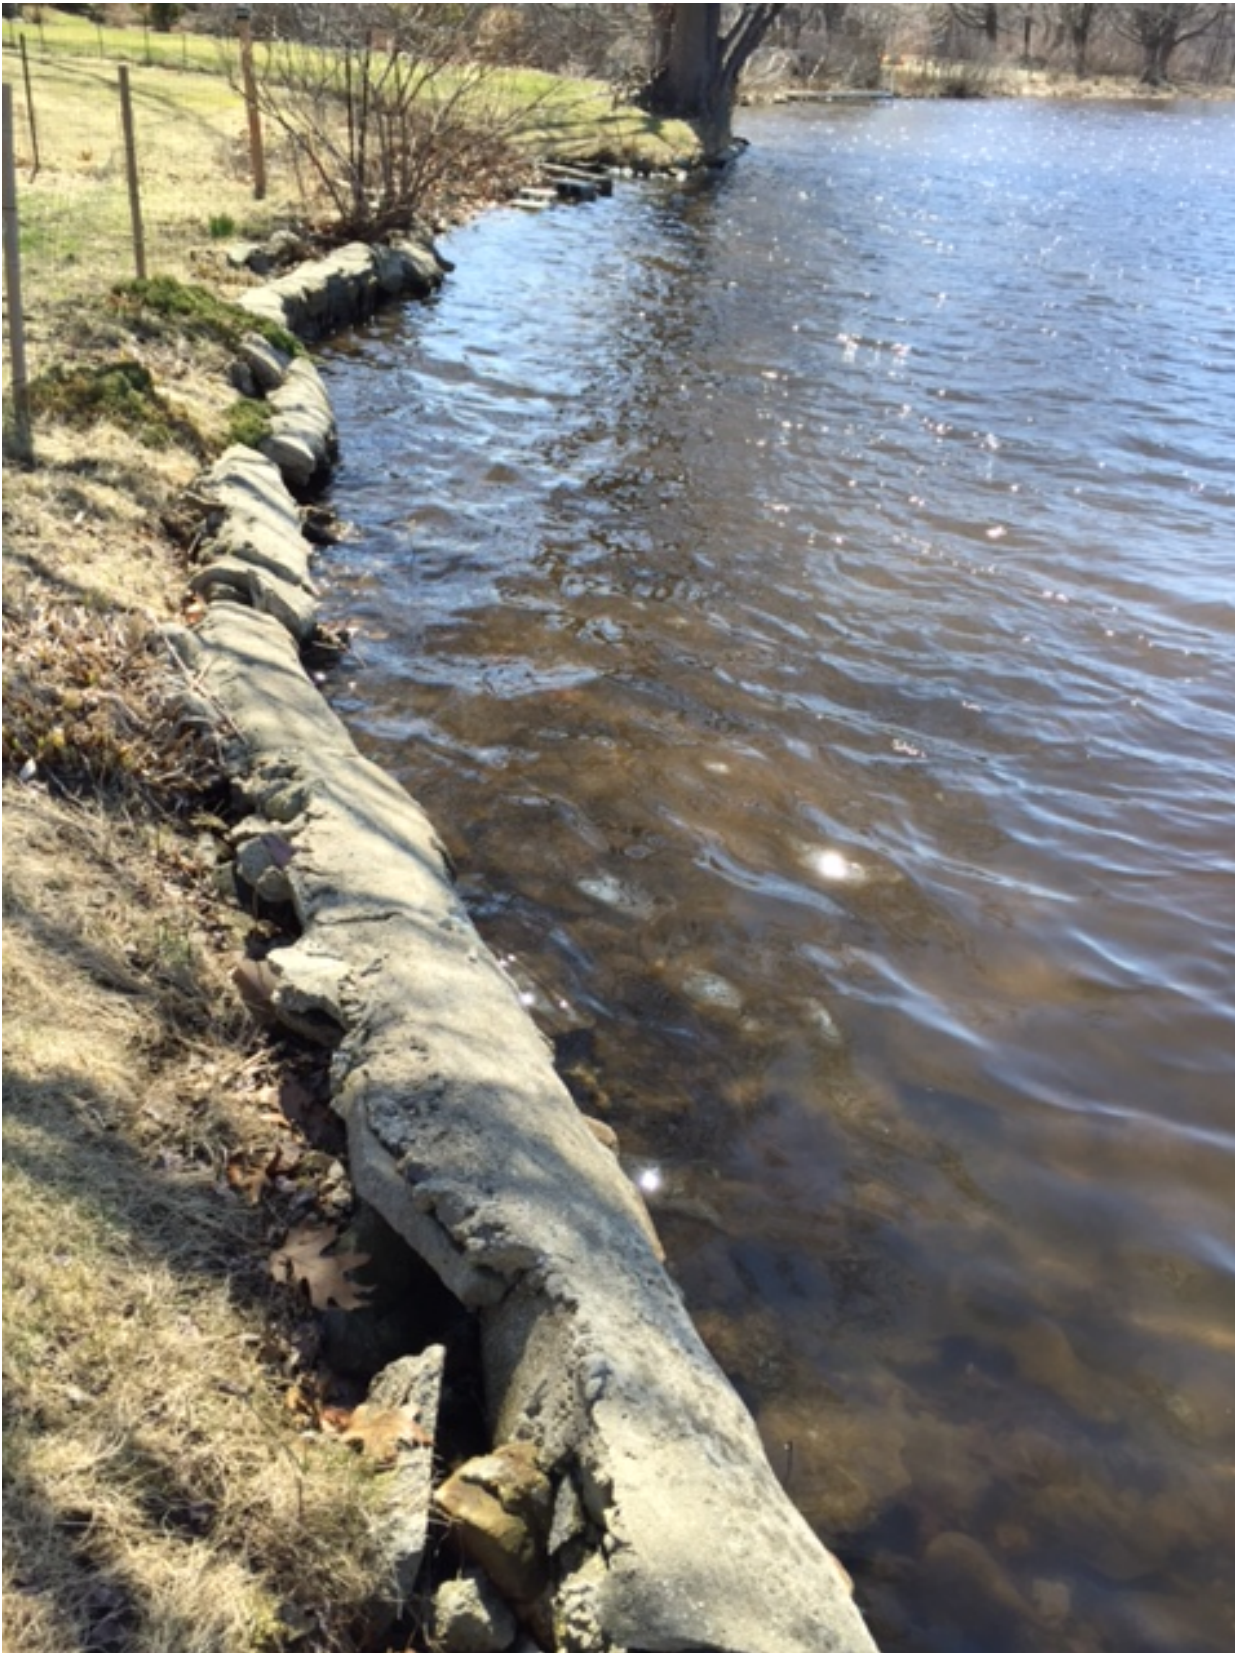
Spring 2015 – Concrete cap beginning to break apart and separate from bank

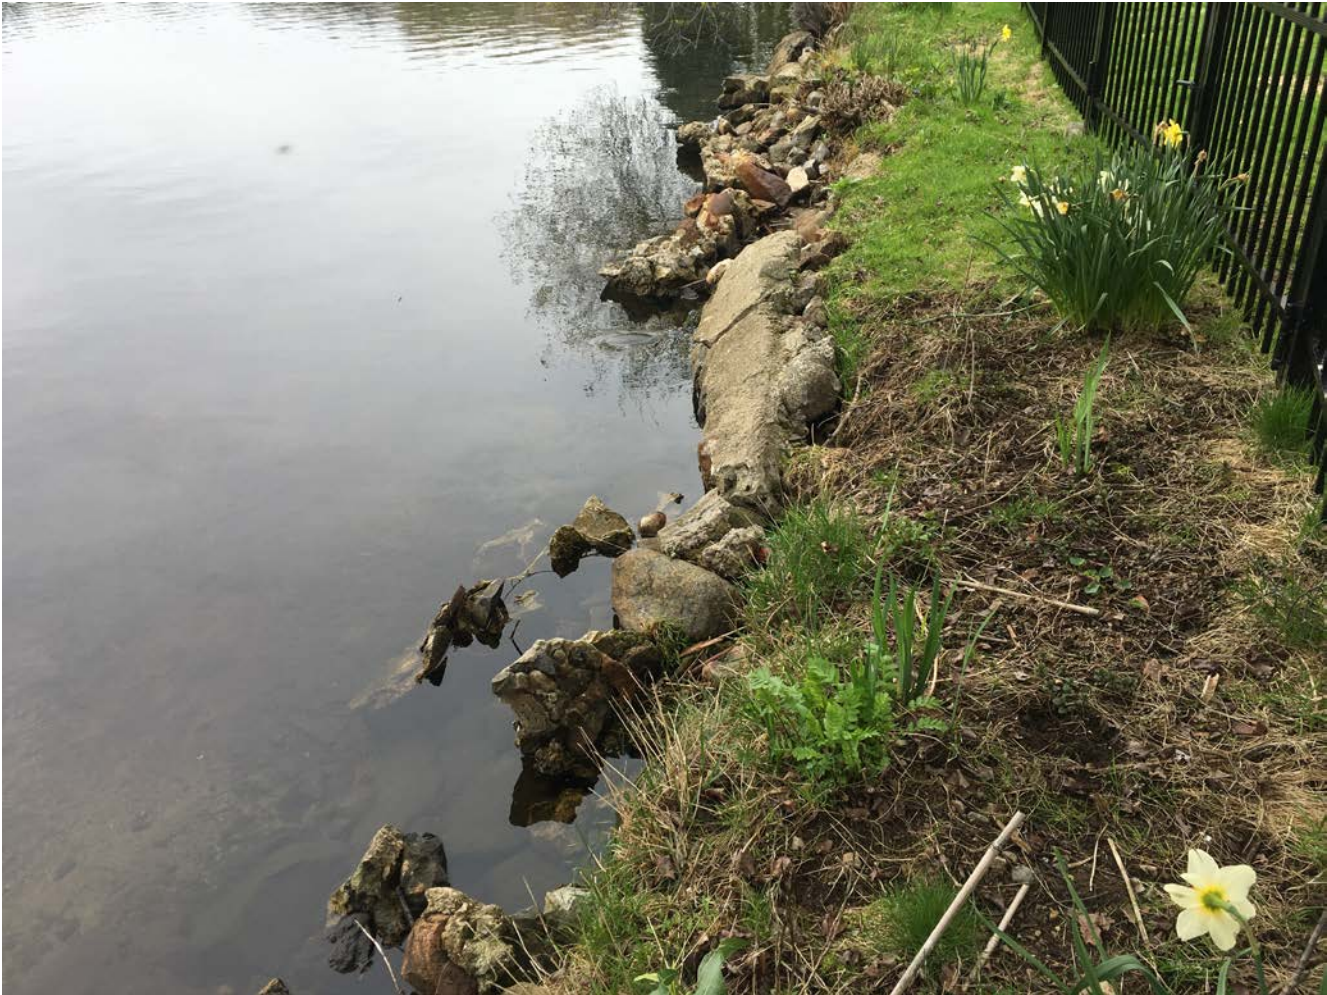
Spring 2019 - Concrete cap degraded and bank eroding in many areas.

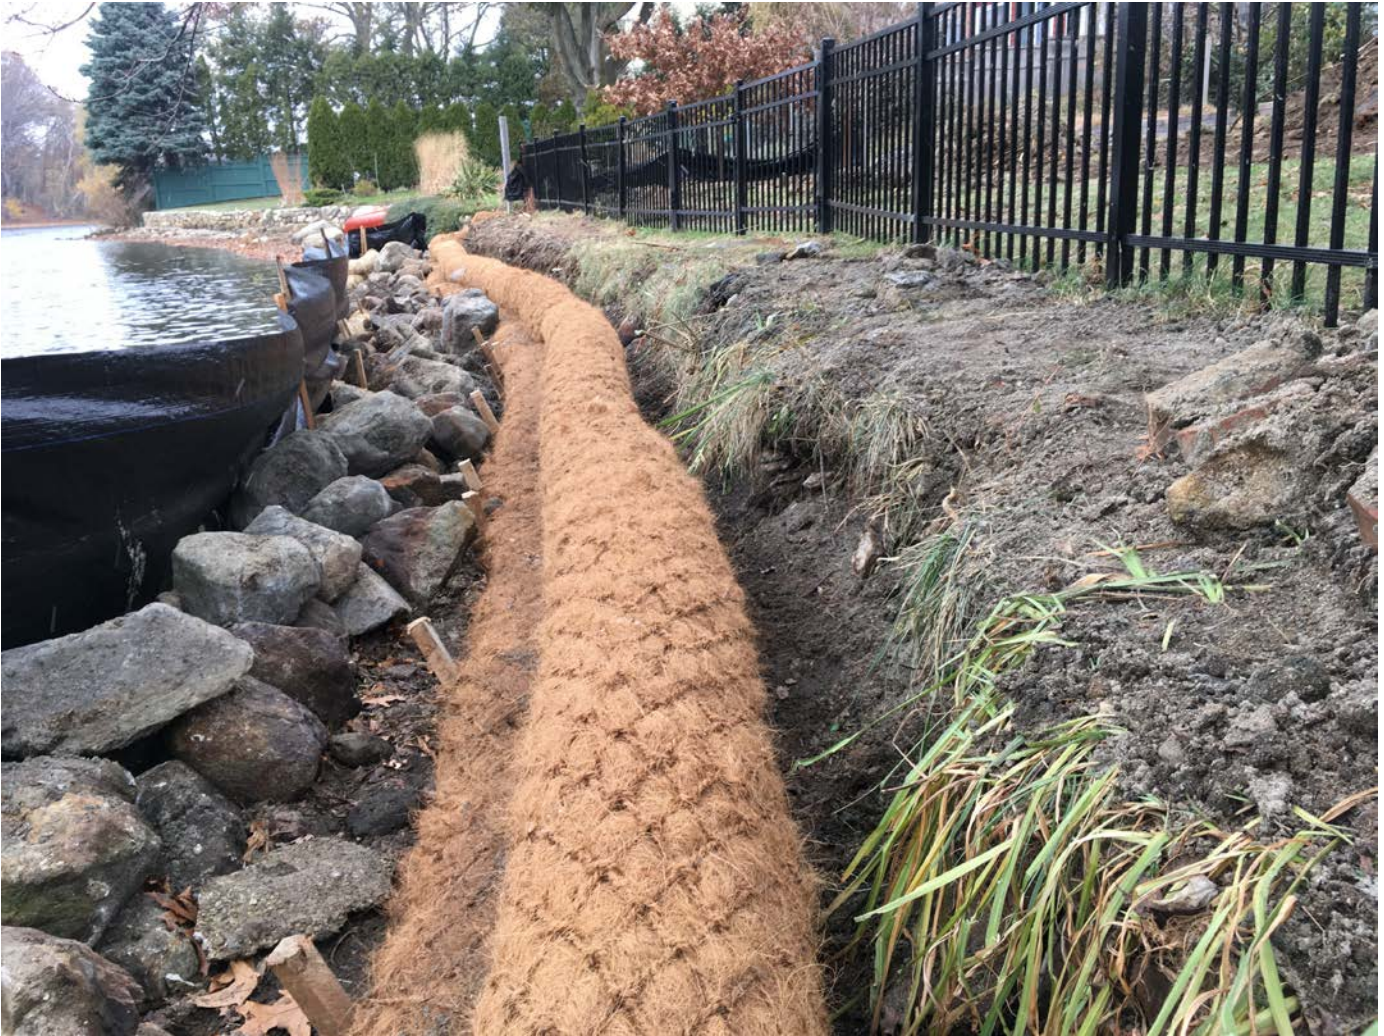
Coir logs installed in 3 tiers; Large stones previously embedded in concrete cap piled up against first coir log tier for stabilization; Plastic sheeting on left to prevent silt and debris from entering pond

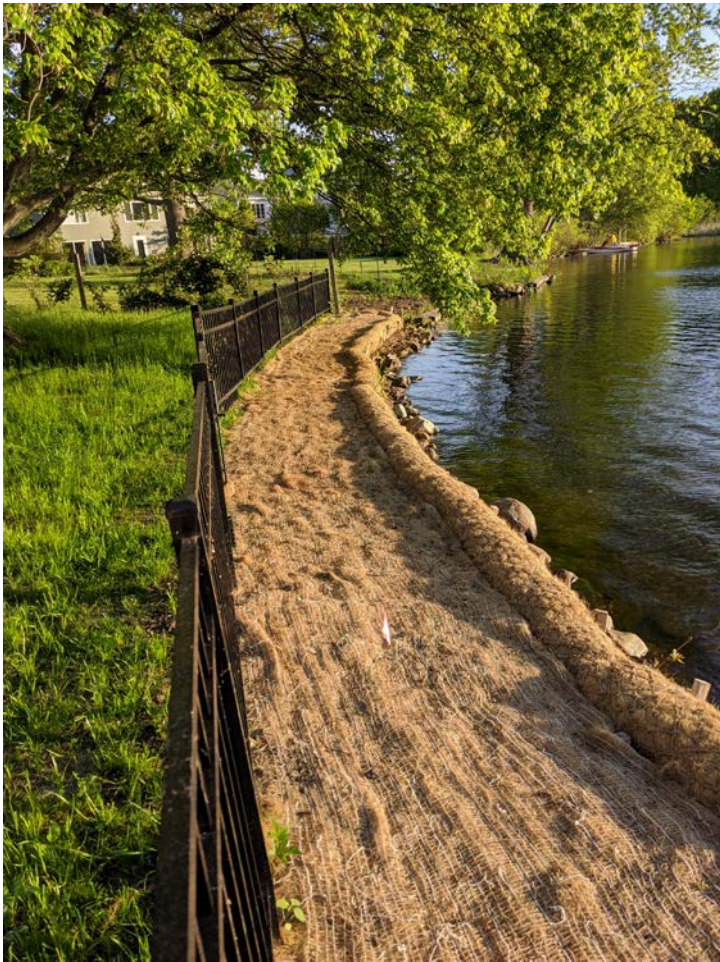
Coir erosion blanket placed on bank top to minimize erosion over winter

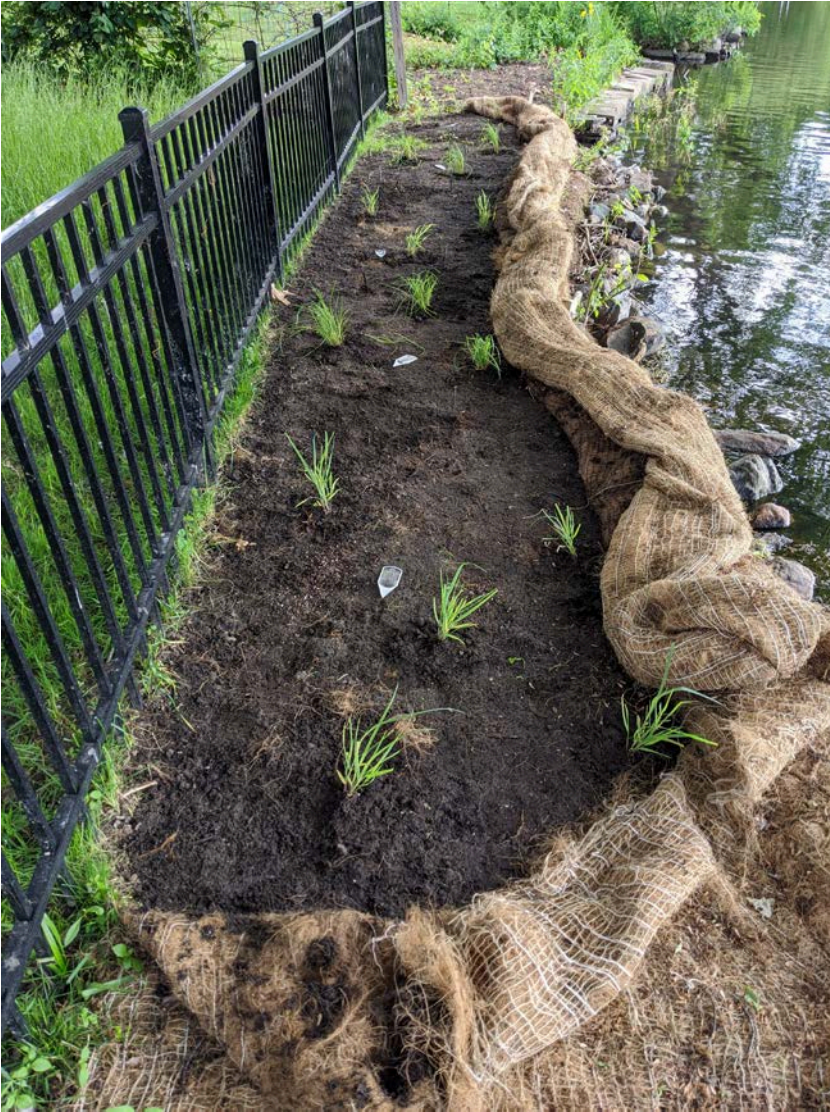
Spring 2020 – Vegetation installation begins, including 3” plugs of Switch Grass (*Panicum virgatum*), Little Bluestem (*Schizachyrium scoparium*), and Rush (*Juncus*) from Santa Rosa Gardens (shown in photo), live stakes of buttonbush, red osier dogwood, and ???, and meadow willow (4” pot from New England Wetland Plants)

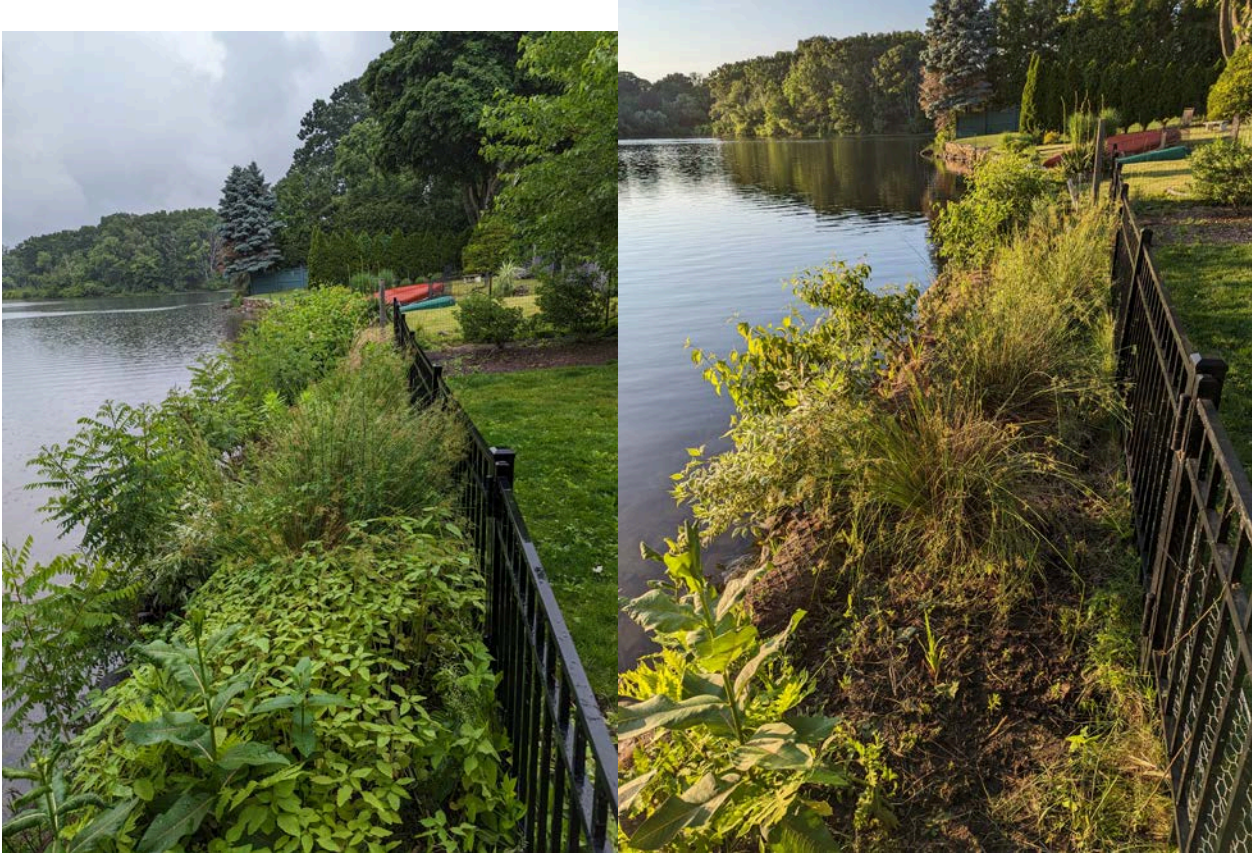
Photos taken from gate towards north

June 2023 – Planted vegetation well established but many invasive species and “weeds” such as false indigo (left – before removal; right – after removal)

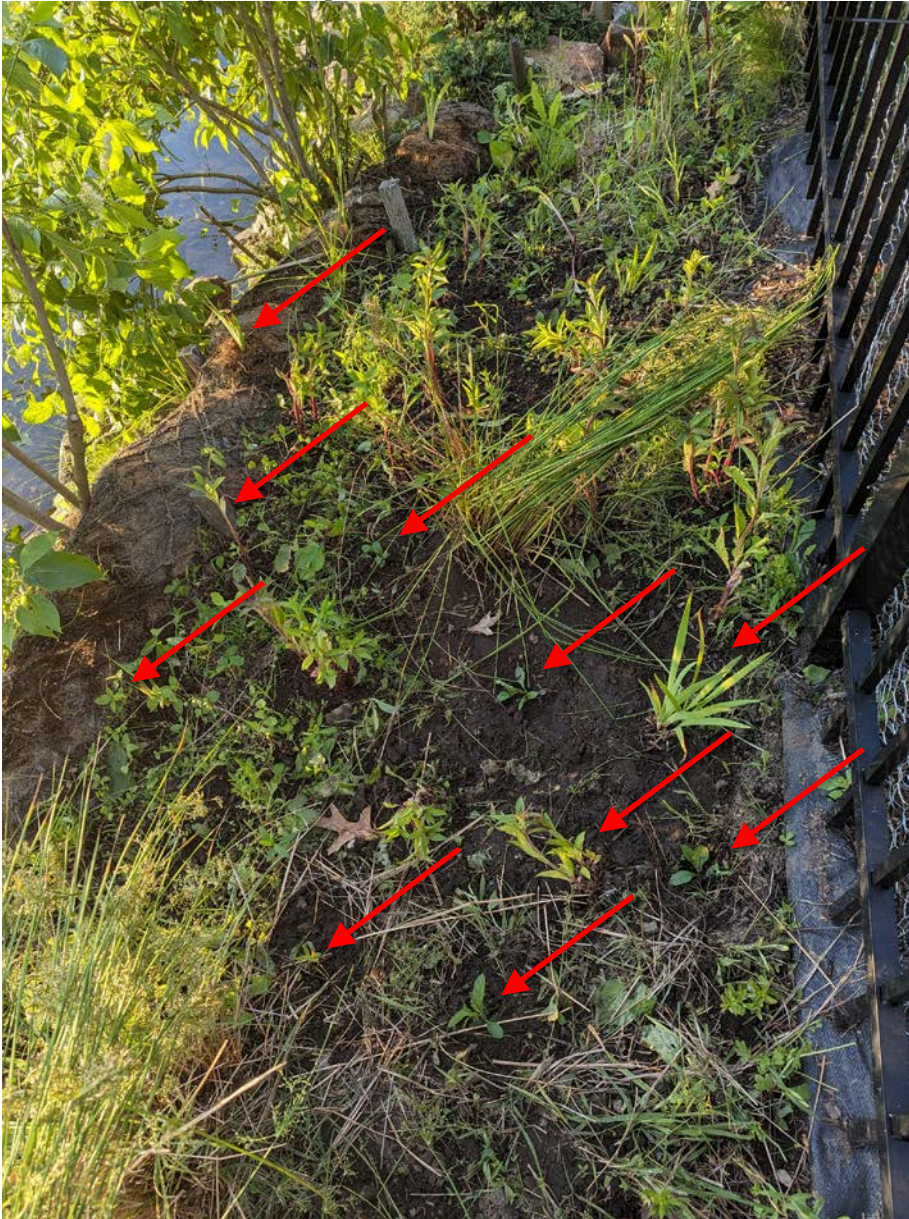
June 2023 – Approximately 500 2" plugs installed at density of ~1 per square foot, including cardinal flower, monkey flower, pickerelweed, tussock sedge, blue vervain, New England aster, and blue flag iris

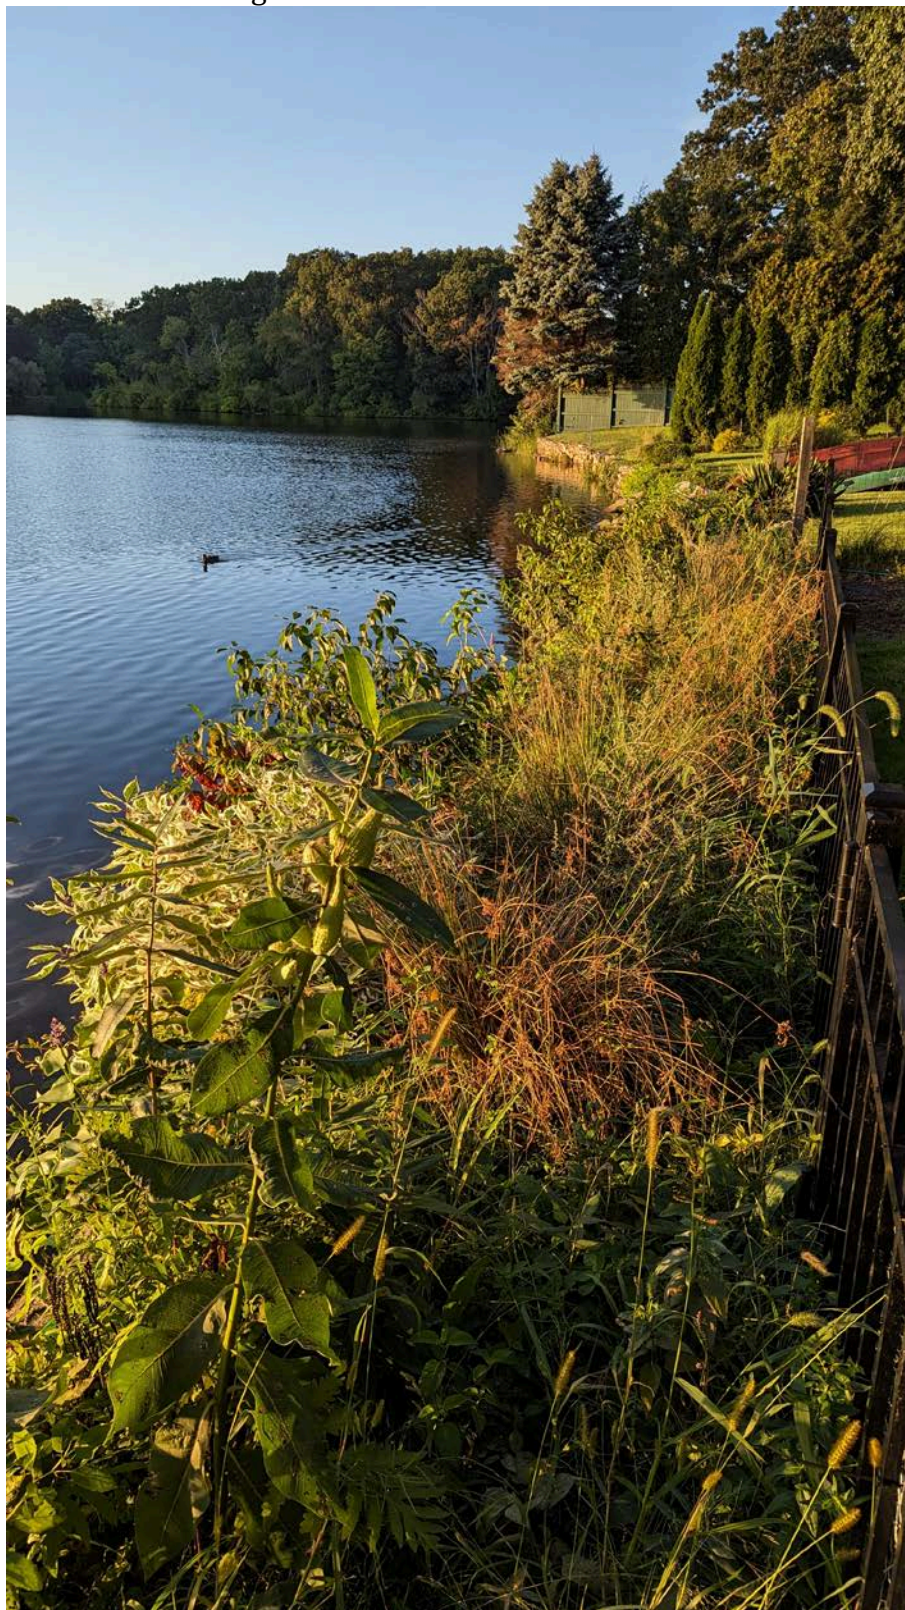
Photo taken from gate towards north

Aug 2023 – plugs becoming established

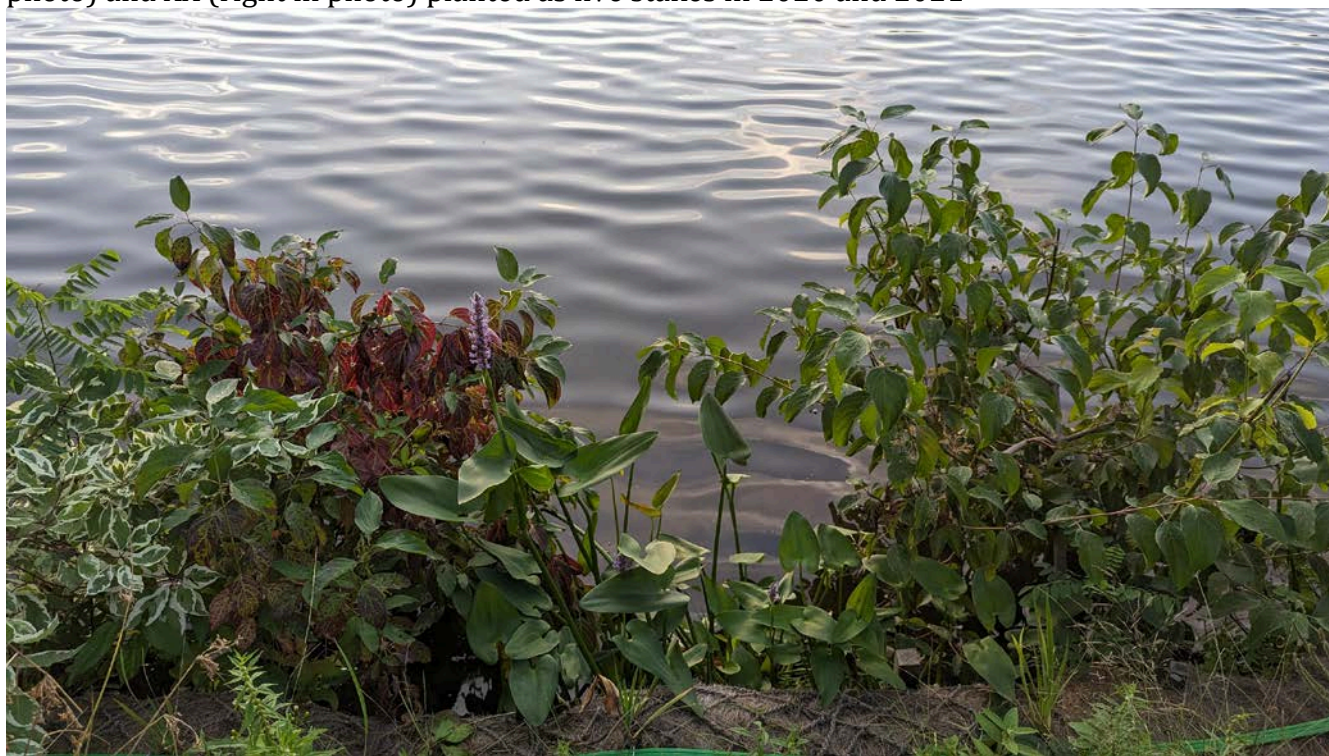
August 2023 - pickerelweed planted as plugs in June 2023 with red osier dogwood and XXX (left in photo) and XX (right in photo) planted as live stakes in 2020 and 2021

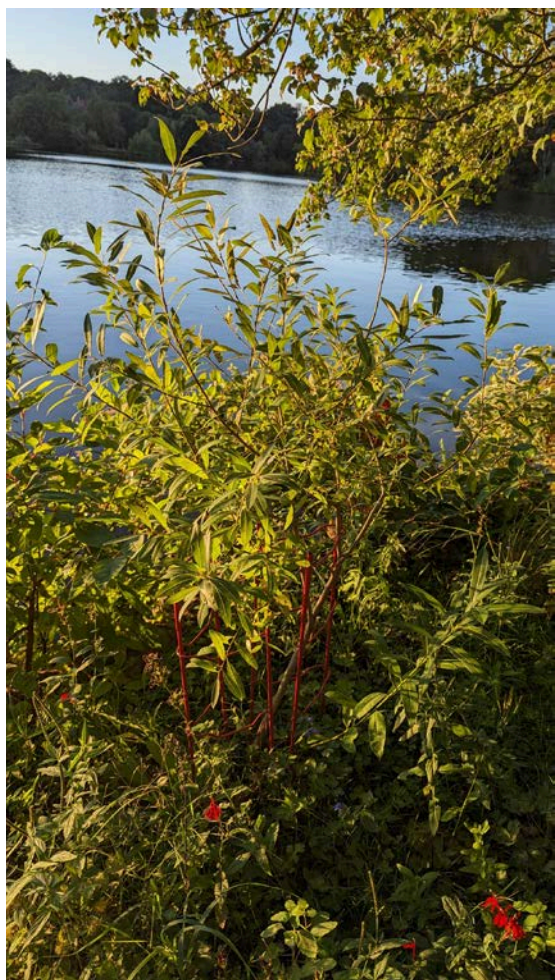
Willow planted as 1 gallon plant in 2021
